CALSPAN ON-SITE AIR BAG DEPLOYMENT INVESTIGATION

CALSPAN CASE NO. 91-08

VEHICLE - 1991 FORD TAURUS

14. Sponsoring Agency Code	
15. Supplementary Notes On-site investigation of an air bag deployment crash that involved a 1991 Ford Taurus. The 35 year old female driver was wearing the active belt system improperly and impacted the left A-pillar, sustaining fatal head injuries.					
<p>16. Abstract This report focuses on a 1991 Ford Taurus that rotated in a clockwise direction and impacted a W-beam guardrail with its frontal area. The crash resulted in a sufficient longitudinal deceleration which closed the crash sensors and deployed the vehicle's driver air bag system. Damage to the vehicle was minimal (2" of residual bumper crush); however, guardrail damage was extensive with 28.5" of crush to the strong post system.</p> <p>The driver of the Ford Taurus was a petite 35 year old female who was wearing the 3-point lap and shoulder belt improperly with the shoulder belt webbing positioned under her left arm. She was slightly out of position to her left at impact due to the pre-crash CW rotation of the vehicle. At impact, she initiated a forward and lateral trajectory to her left in

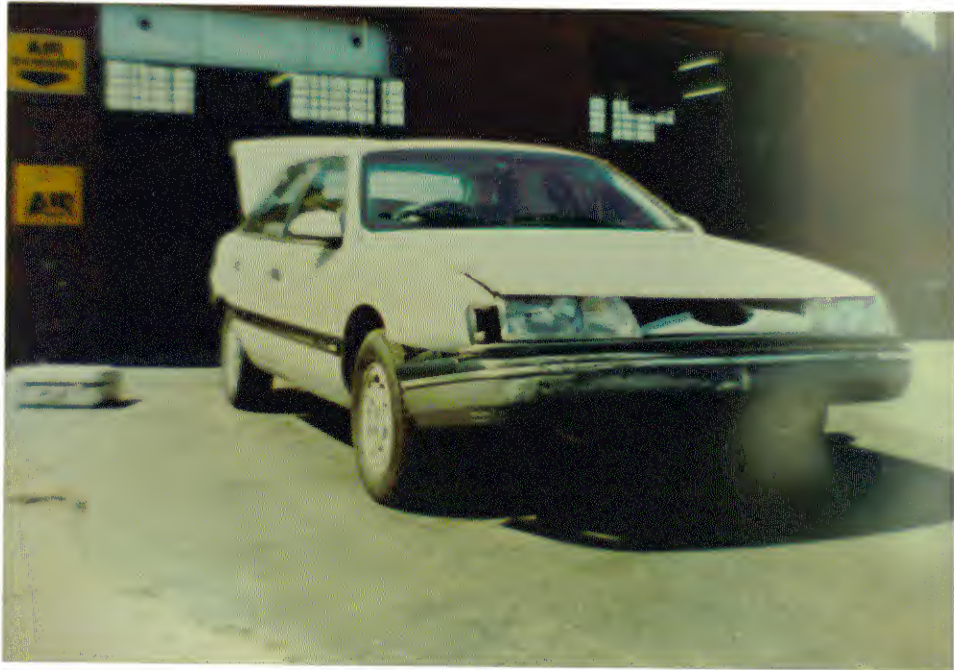
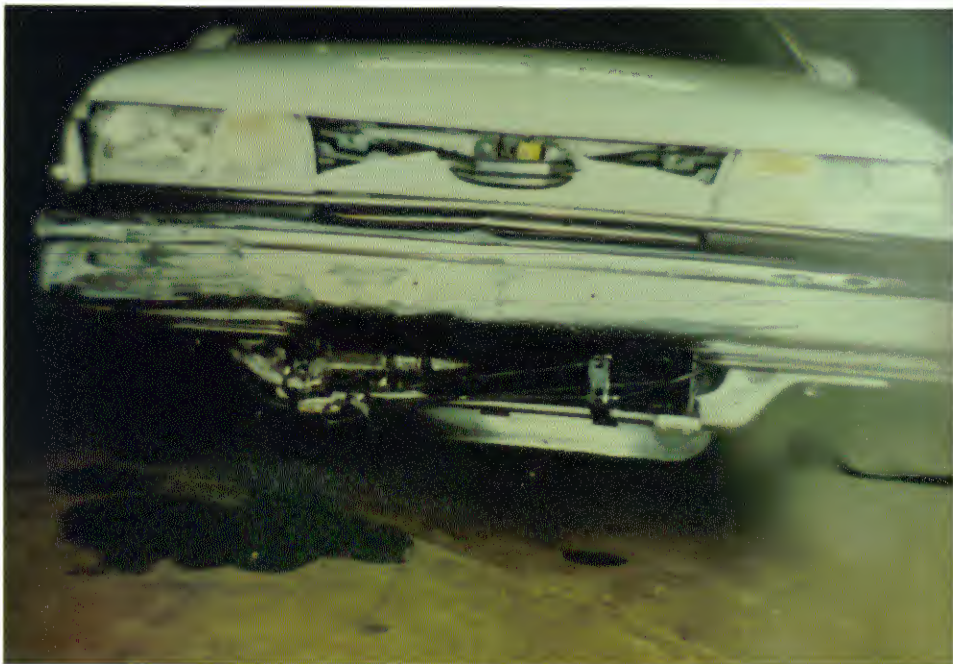
Primary - The frontal area of the Ford Taurus impacted a W-beam guardrail which resulted in minor damage to the bumper and adjacent components. Maximum crush was 2.0" that was located at the right corner of the bumper. Direct contact damage on the bumper face began 22" left of the vehicle's center line and extended 52.4" to the right corner. The impact compressed both bumper energy absorbing devices (EADs) which resulted in a combined induced and direct contact damage length of 60.25" that involved the entire bumper. The left bumper EAD compressed 0.4" while the right unit compressed 1.6". Both EADs returned to their original pre-crash positions. Crush values were measured at six equally spaced increments across the front bumper and were as follows:  
C<sub>1</sub>=0", C<sub>2</sub>=0", C<sub>3</sub>=0", C<sub>4</sub>=0.1", C<sub>5</sub>=1.0", C<sub>6</sub>=2.0".

Frontal Damage To The Ford Taurus.

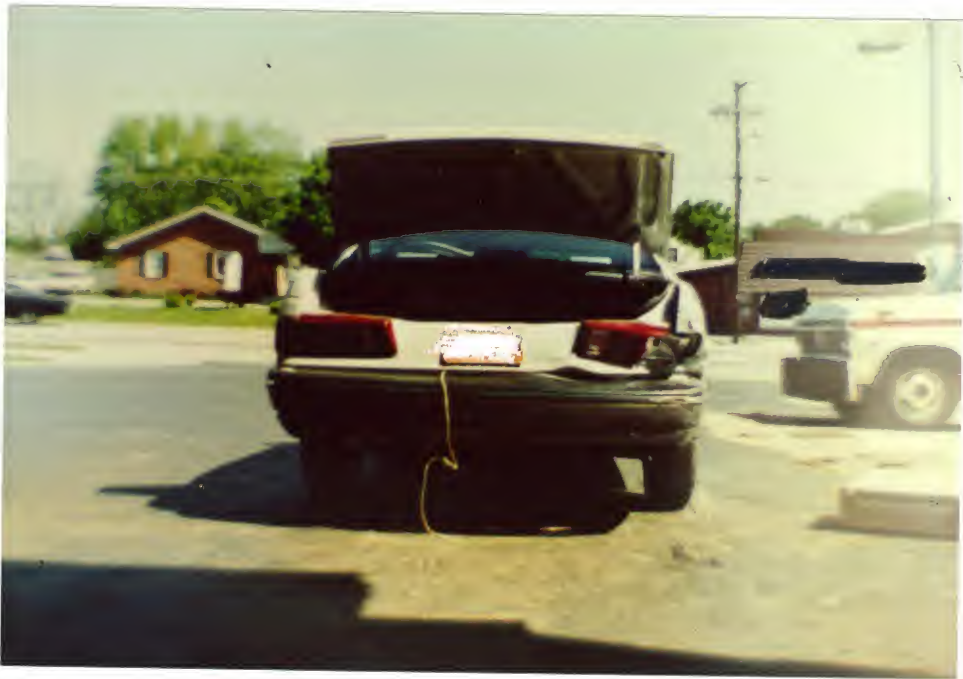
Secondary - The right rear area of the Ford Taurus impacted the median W-beam guardrail as the vehicle rotated across the travel lanes. Direct contact damage on the rear bumper began 17.5" right of center and extended 12.6" to the right rear corner area. Although no residual bumper crush occurred (no EAD compression) as a result of the impact, the right taillamp area of the vehicle engaged with the guardrail resulting in 4" of sheetmetal crush at the right rear corner.

Secondary Guardrail Damage To The Right Rear Corner Area.

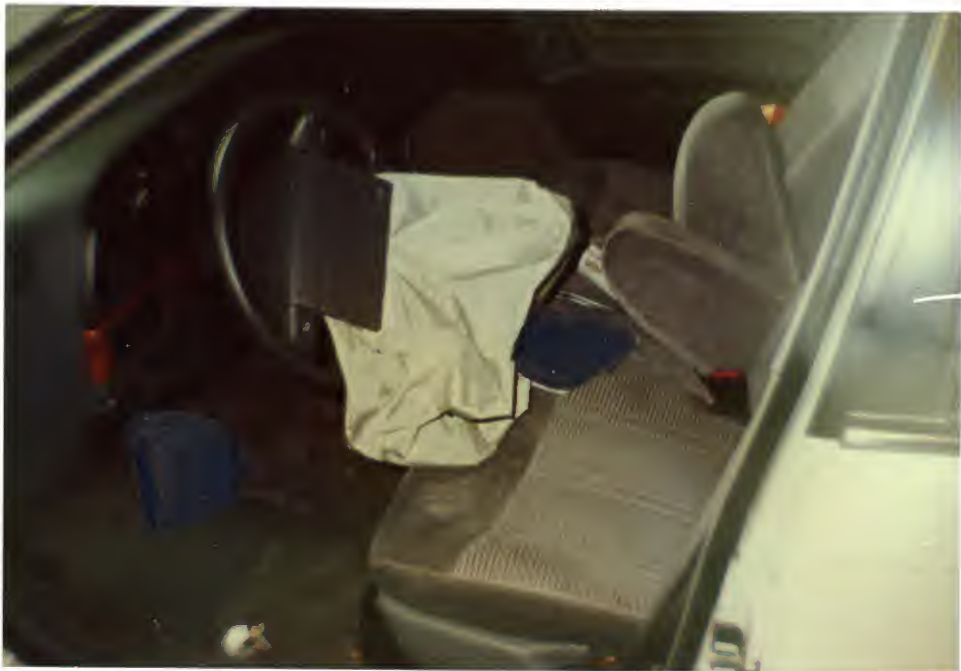
The interior of the Ford Taurus sustained minor damage that was associated solely with occupant contact. The driver's thoracic area loaded the steering assembly through the air bag and deformed the upper steering wheel rim 0.75" forward. Her loading force was transmitted into the steering column which compressed the energy absorbing steering column 1.1". The driver's involvement with the steering assembly fractured and deformed the right cruise control switches that were located between the upper and lower spokes, adjacent to the air bag module. Her knees contacted the steel knee bolster 7-8.25" and 13.9-15.1" left of center. Although no residual damage occurred to the bolster, scuff marks identified the contact areas. The driver's left facial area impacted the mid left A-pillar. Again, no residual damage occurred to the pillar; however, tissue transfers evidenced the contact area. Blood stains were noted to the face of the deployed air bag and on the active belt webbing in the area of the latchplate.

Overall Interior View And Of The Deployed Air Bag And Upper Module Cover Flap.

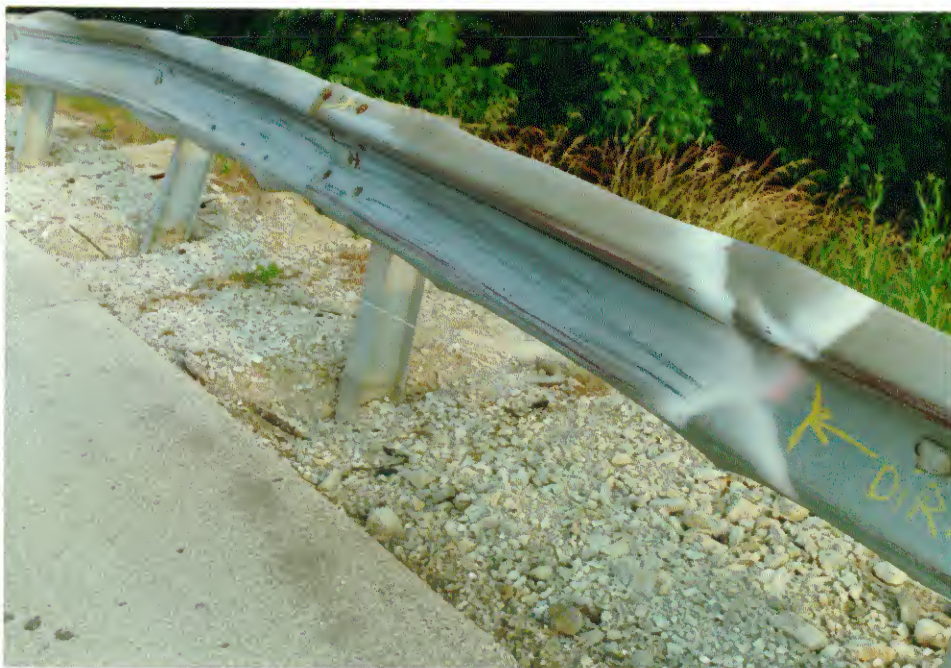
The frontal area of the Ford Taurus directly contacted 23'9" of the W-beam guardrail system. The force of the impact deformed 59'5" of the guardrail to a maximum depth of 28.5" and displaced six guardrail posts. Post displacement ranged from 1-14" of movement. Within the area of the deformed guardrail, red paint transfers were visible on the W-beam and red plastic debris was found in the area, indicating that this section of guardrail had sustained an impact prior to this crash. The extent of damage to the guardrail system from the previous impact was unknown.

Beginning Of Direct Contact Damage on Guardrail,  
Also Note Unrelated Red Paint Transfers.

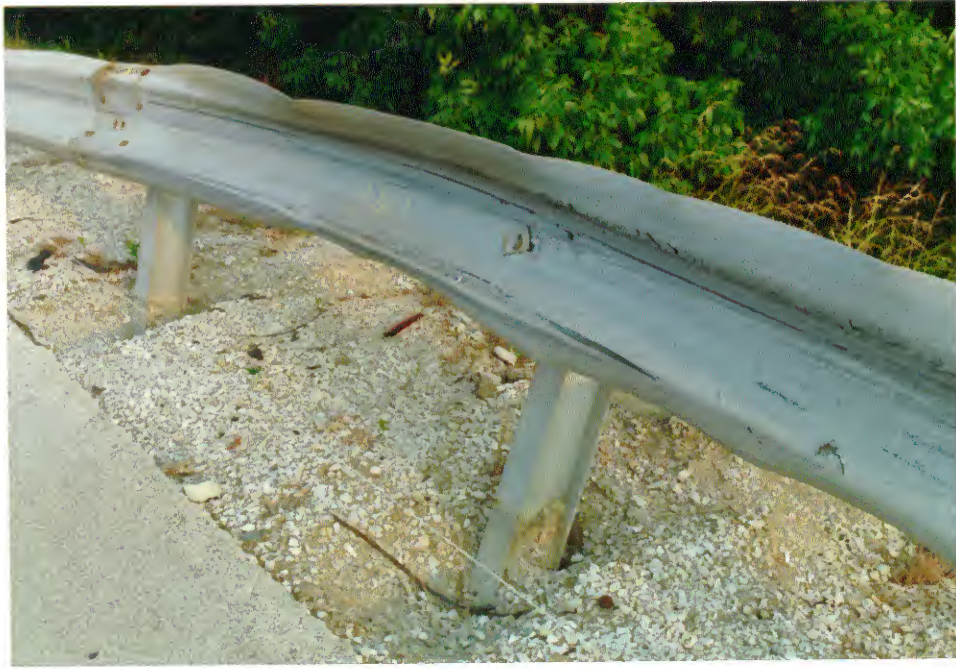
Maximum Displacement of Guardrail.

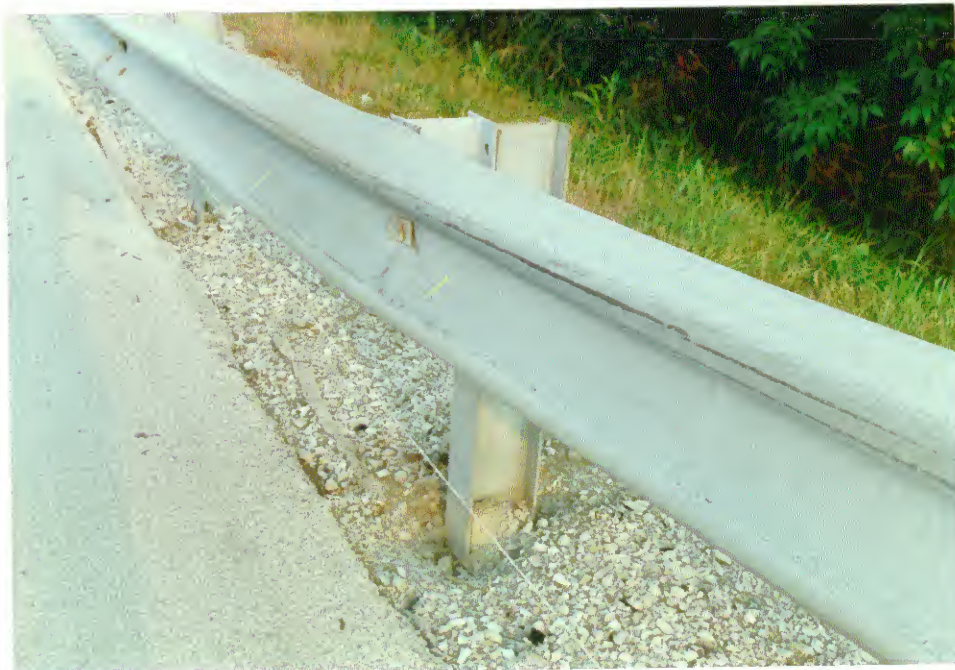
End of Direct Contact Damage.

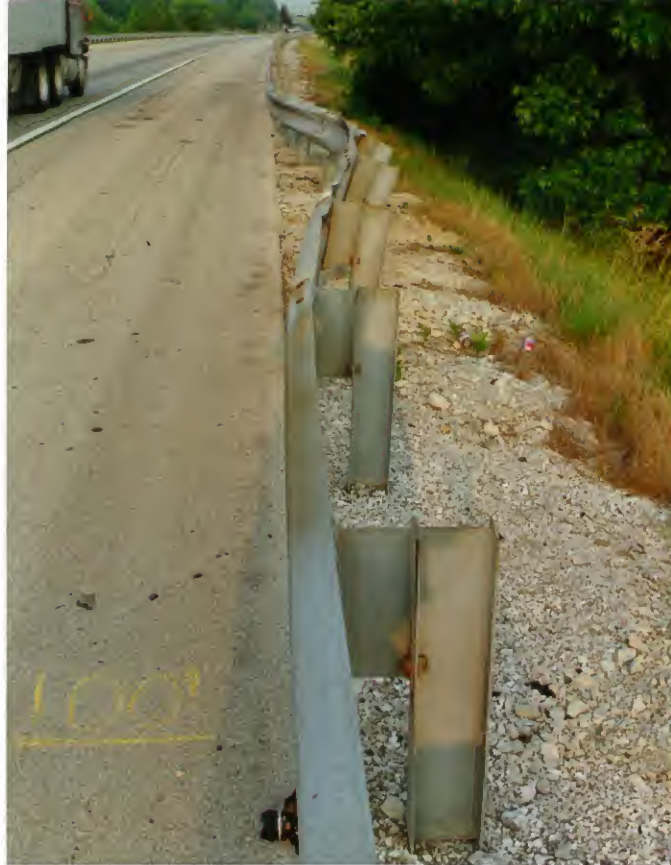
Longitudinal View Showing The Extent Of Guardrail Displacement.

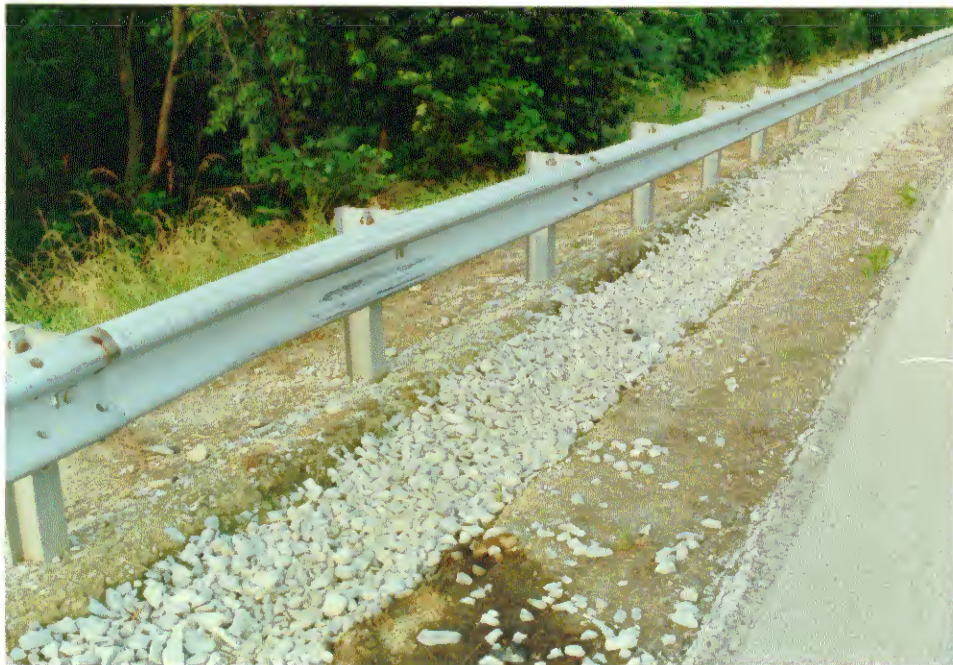
Secondary Guardrail Impact Damage.

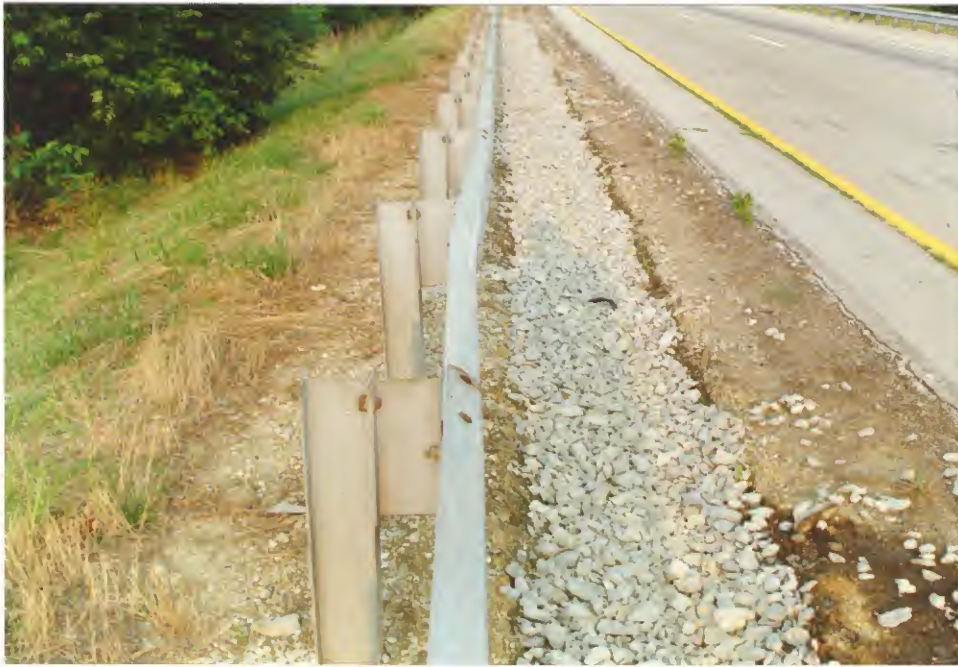
Longitudinal View Of The Guardrail Damage.

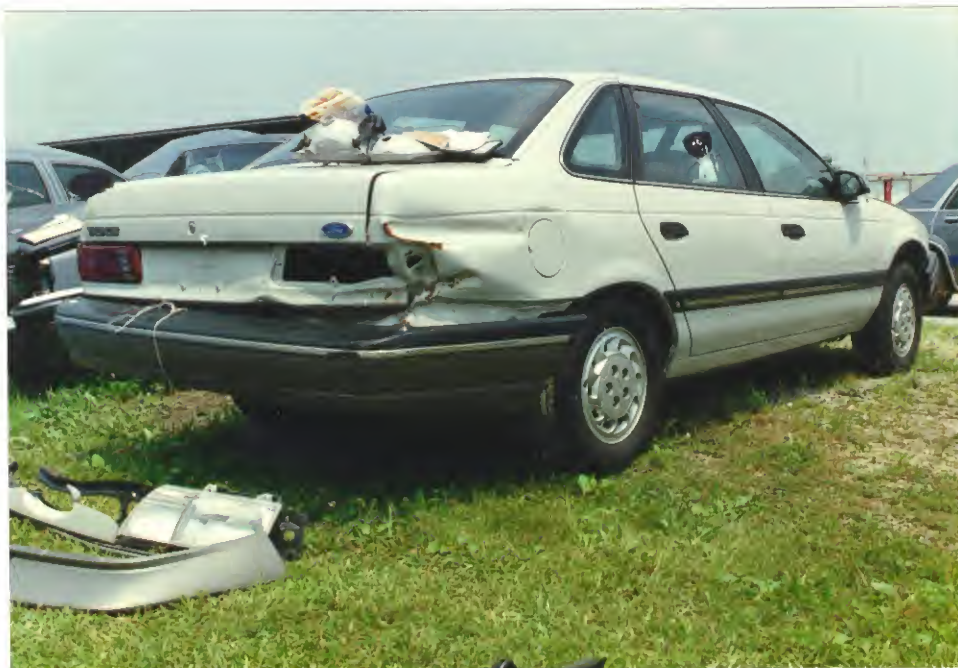
Secondary Guardrail Impact Damage To The Right Rear Area.

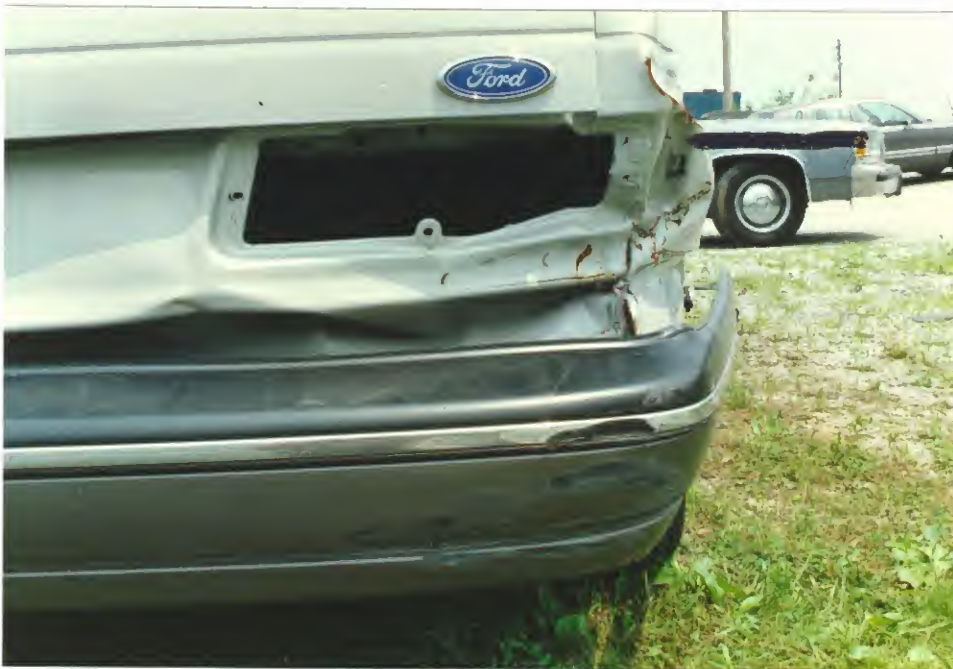
Direct Contact Damage Across The Right Rear Bumper Area.

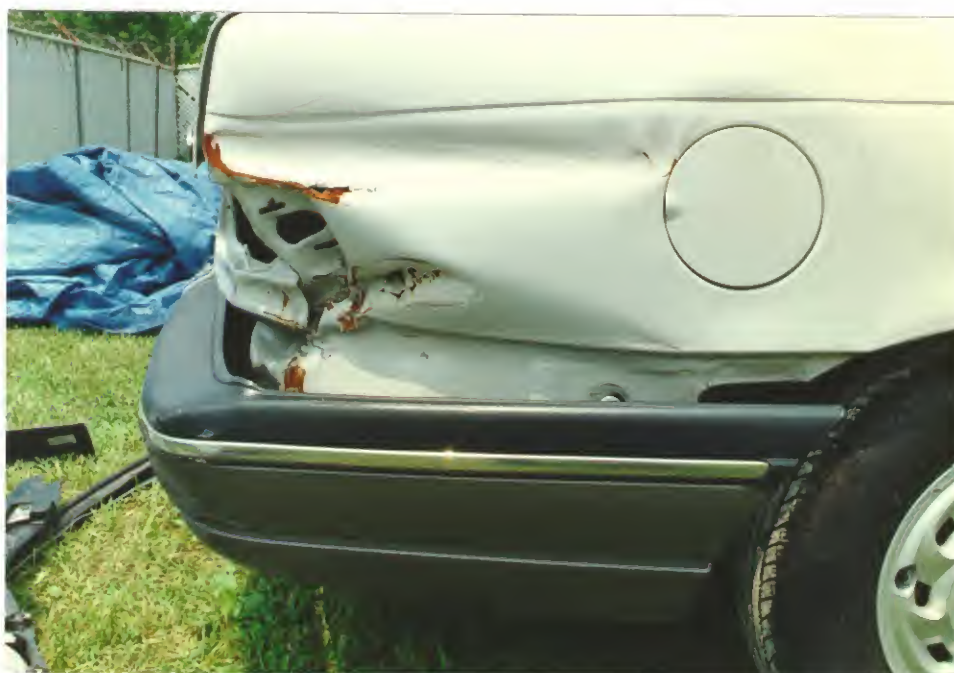
The right rear quarter panel area of the vehicle engaged with the guardrail as the vehicle continued in a rearward direction before coming to rest. Direct contact damage began at the corner area of the sheetmetal and extended forward 23.125", ending 16.75" rearward of the right rear axle position.

Damage That Extended Onto The Right Quarter Panel.

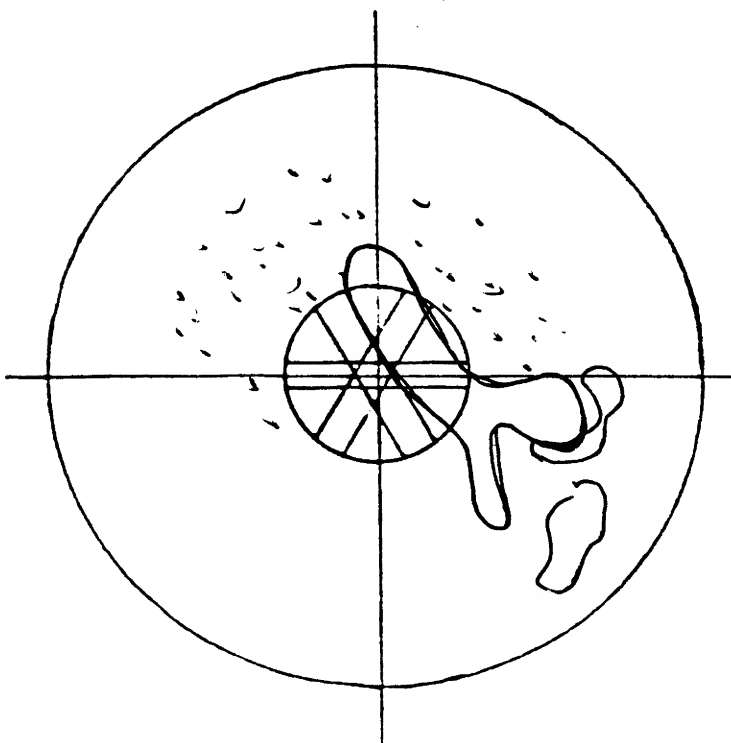
BLOOD STAIN ON AIR BAG
